**BAY TO BEACH**  
HOME INSPECTIONS LLC

## Home Inspection Report

123 Anywhere St  
Niceville, FL 32578

Inspected By: Mike Pierce

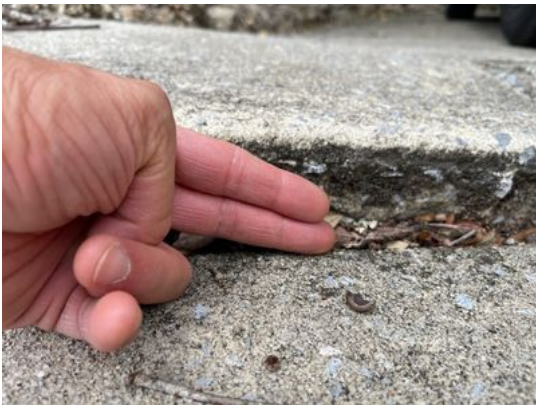
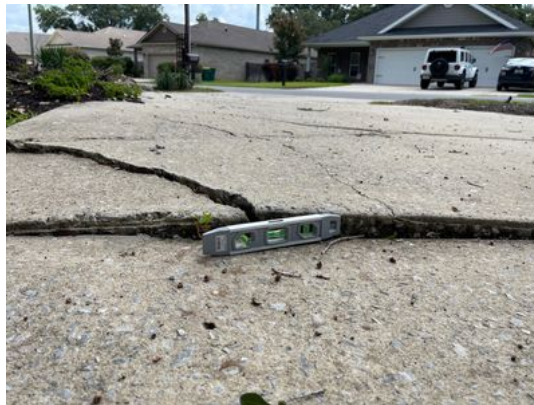
Concrete in drive has been lifted by roots and is a trip hazard. Recommend repair to eliminate safety concern.

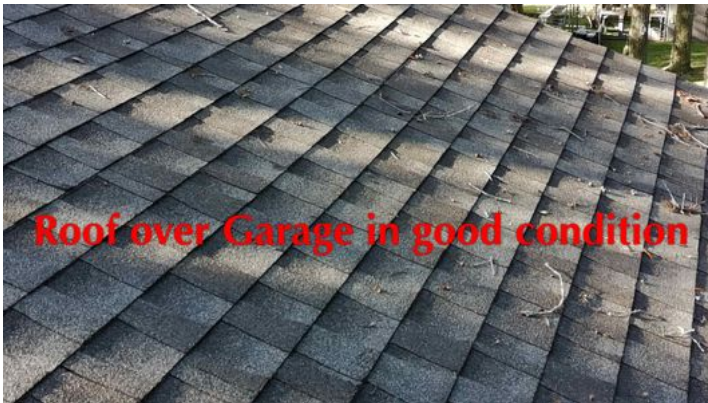
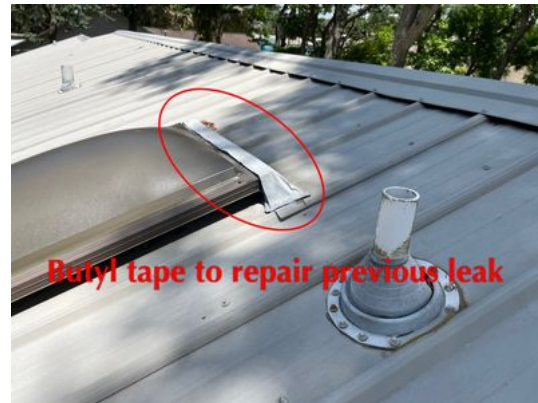
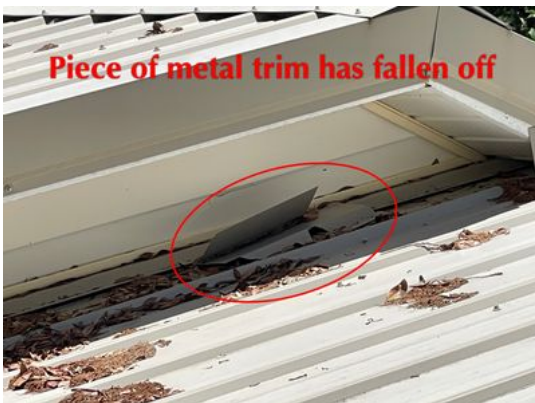
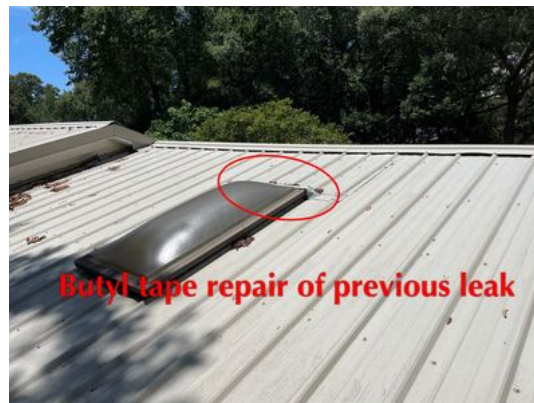
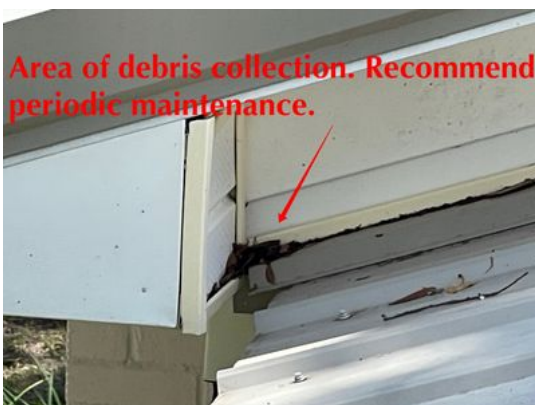
The metal roofing on the house is in decent condition but has some concerns. According to the permit pulled, it was installed in 2006. No signs of current leaks were detected, it is recommend to monitor the vent stack boots and skylights for leaking and have a qualified contractor replace the piece of trim to where it fell off.

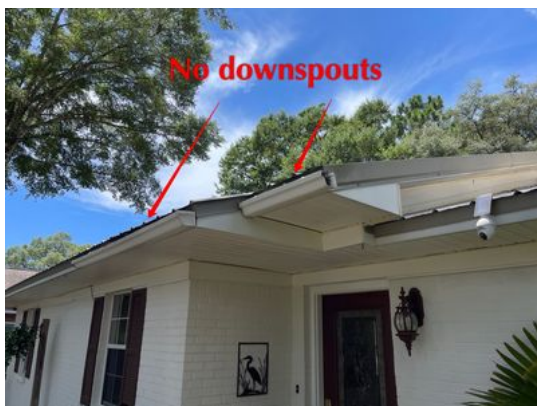
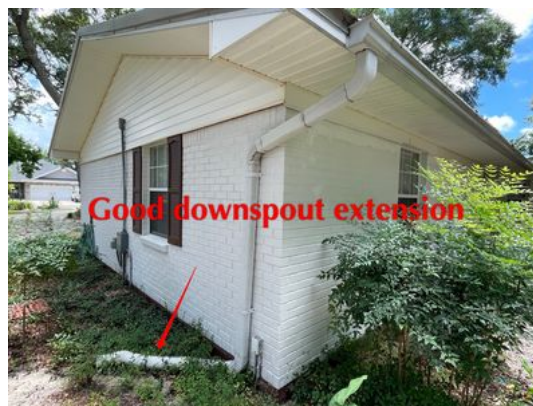
The gutters at the front of the house are missing downspouts. Other areas have no gutters. This could allow water to pool at the foundation. Water should be directed 6 feet away from the foundation. The back of the house has an aluminum gutter with a proper extension on the downspout.

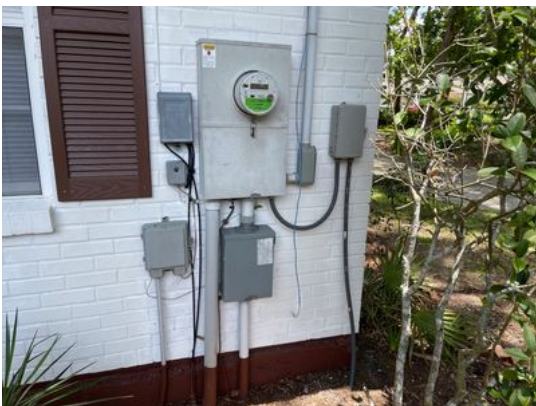
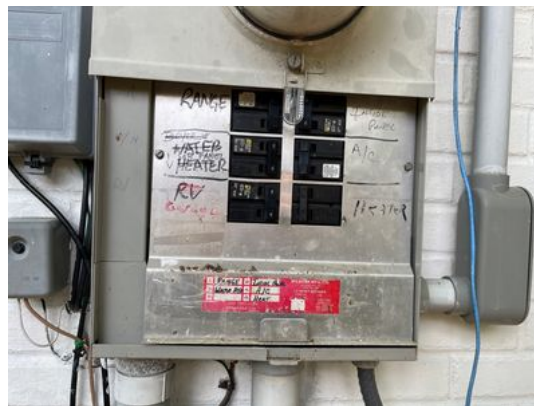
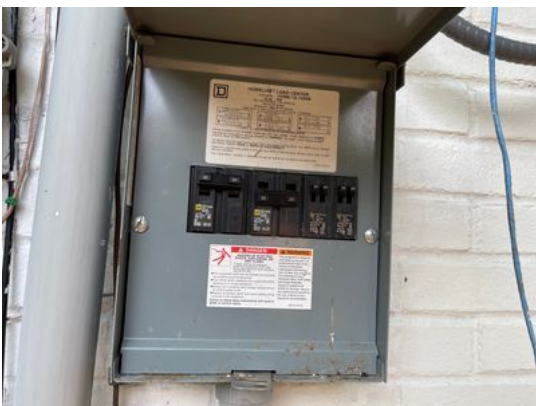
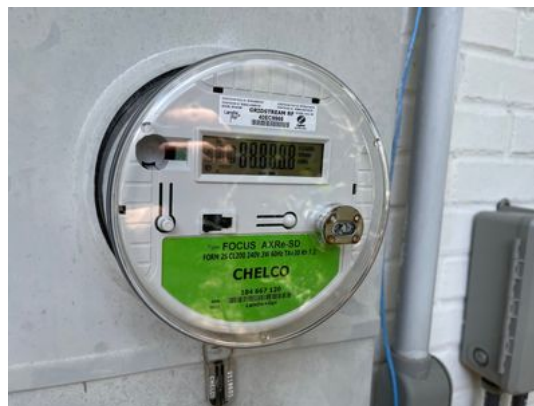
Service panel is located on the southwest wall (left side) of the home. There is no main shutoff breaker to the electrical system. A complete power shutdown to the home and garage will require flipping 6 breakers.

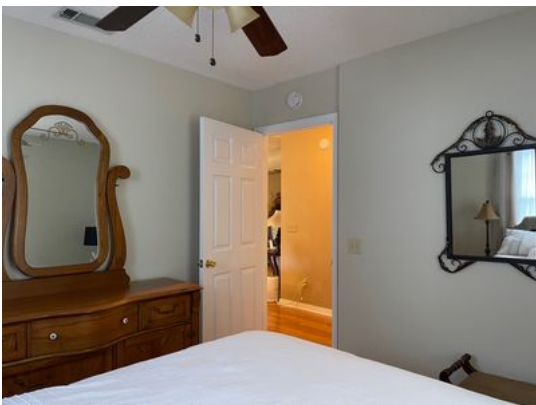
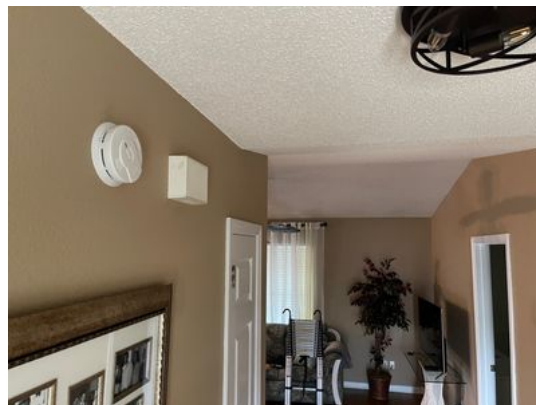
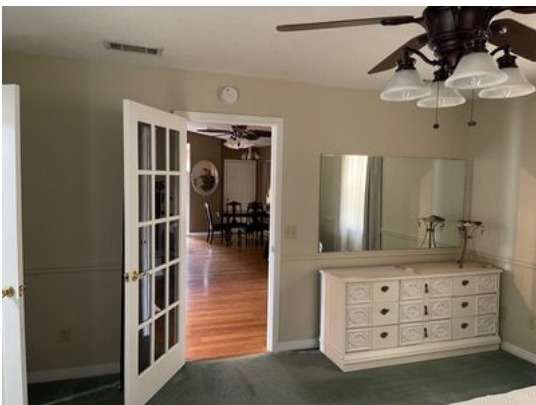
Smoke detectors are battery operated.

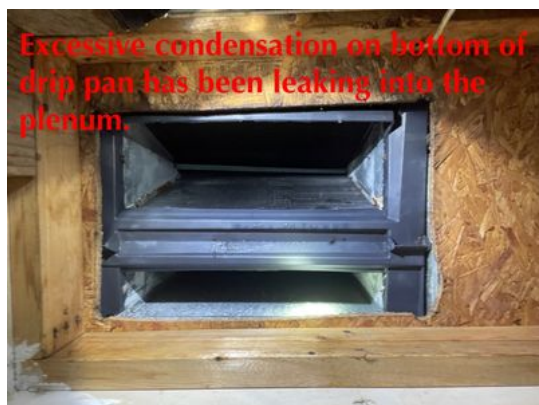
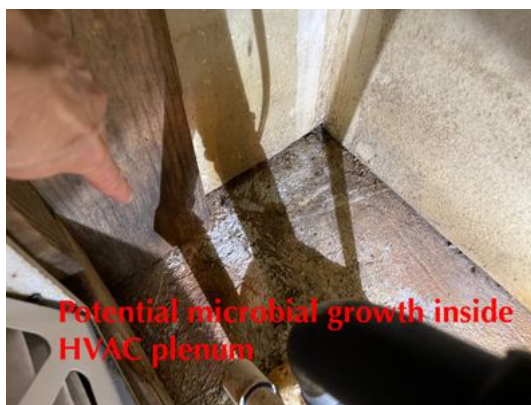
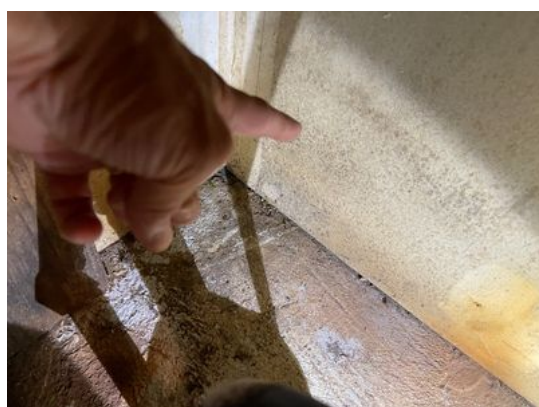
Potential microbial growth inside HVAC plenum. Recommend evaluation by a licensed mold inspector.

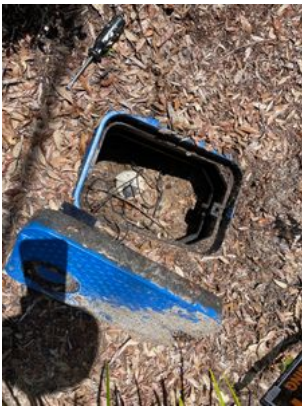
Water supply shut-off is located at the meter. The meter is at the street to the right of the driveway when facing the house.

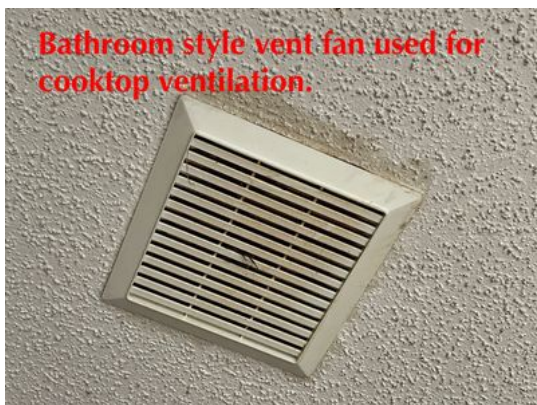
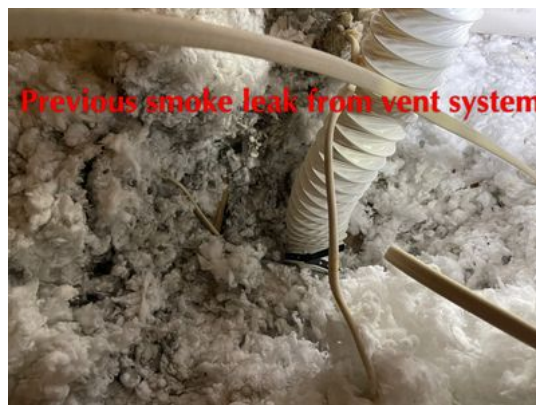
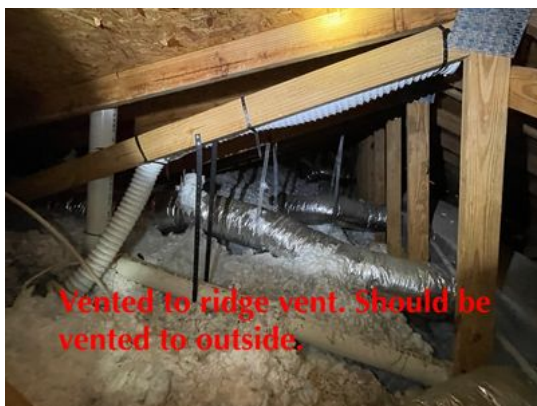
Kitchen ventilation terminates at the ridge vent inside the attic. Recommend a qualified contractor install exterior ventilation.

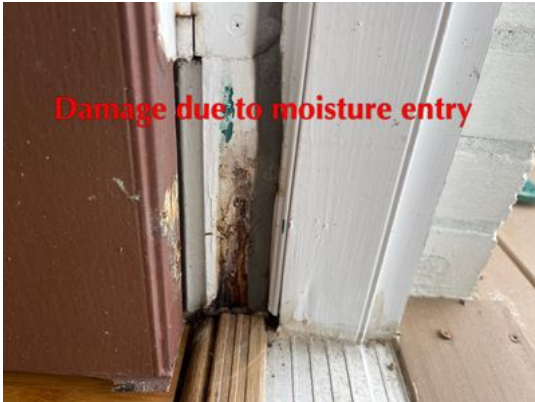
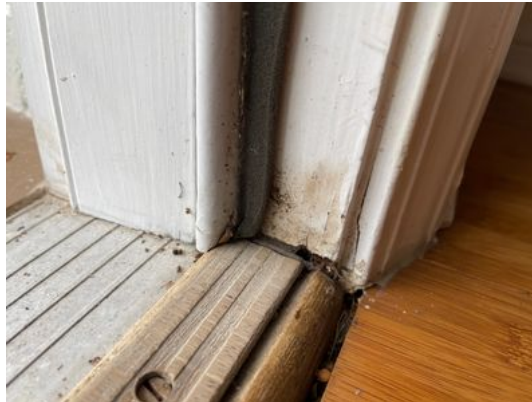
Moisture intrusion noted on both sides of the main entry door. Recommend a qualified contractor repair the damaged door frame and install new weatherstripping.

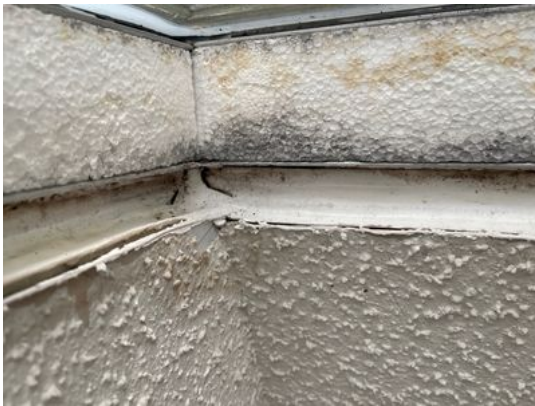
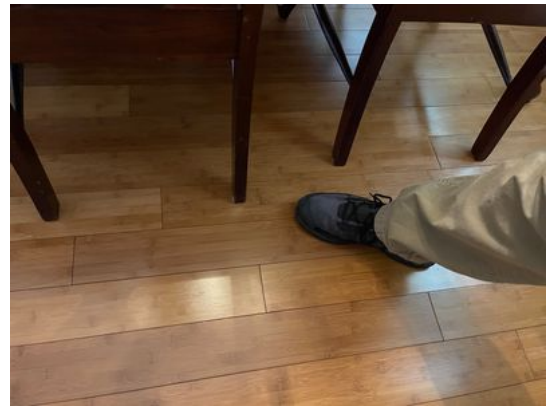
Interior shows signs of good maintenance, but has had previous problems. The staining around the skylights is from a previously repaired leak. There is a soft spot in the bamboo flooring as if there is a dip in the sub-floor beneath it.
